NASA Contractor Report 202323

Insoluble Coatings for Stirling Engine Heat Pipe Condenser Surfaces

Phase II: Final Report

Peter M. Dussinger and James E. Lindemuth
Thermacore, Inc.
Lancaster, Pennsylvania

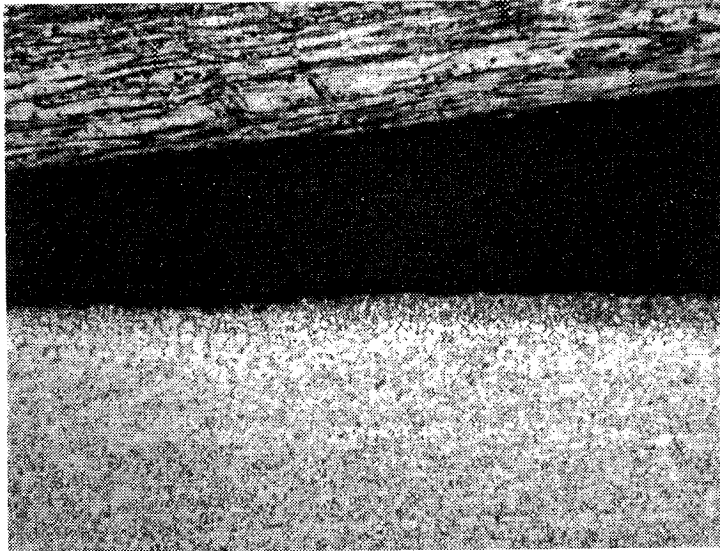
Task 2
Sample No. 56, edge

Magnification: 200x
Etched

Ud720LI Test Vehicle.
Sample Tube No. 21
2-step nickel aluminide coating.
Four tungsten reference stripes.
2.0in from end cap.

Coating thickness: 0.00157cm.
Stripe split within thickness.
No visible signs of corrosion.

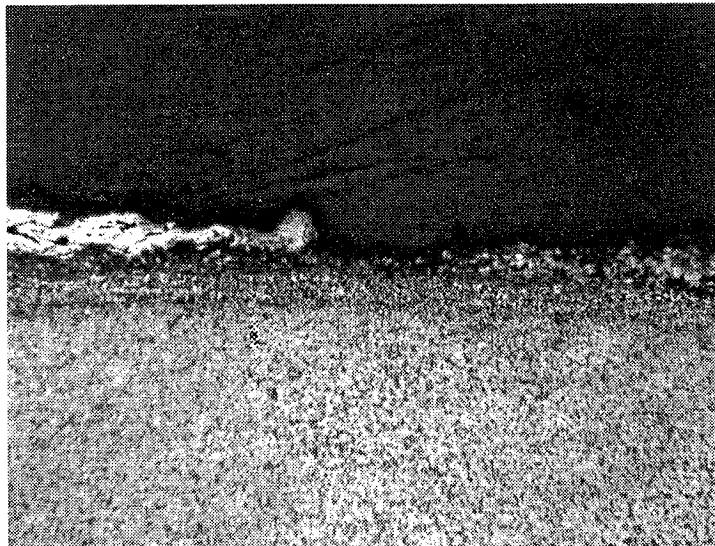
Task 2
Sample No. 60, edge

Magnification: 200x
Etched

Ud720LI Test Vehicle.
Sample Tube No. 22
2-step nickel aluminide coating.
Four tungsten reference stripes.
3.0in from end cap.

Coating thickness:
0.00079cm to 0.00239cm.
Stripe thickness:
0.00157cm to 0.00318cm.
No visible signs of corrosion.
Tested 1886 hours at 1073K.

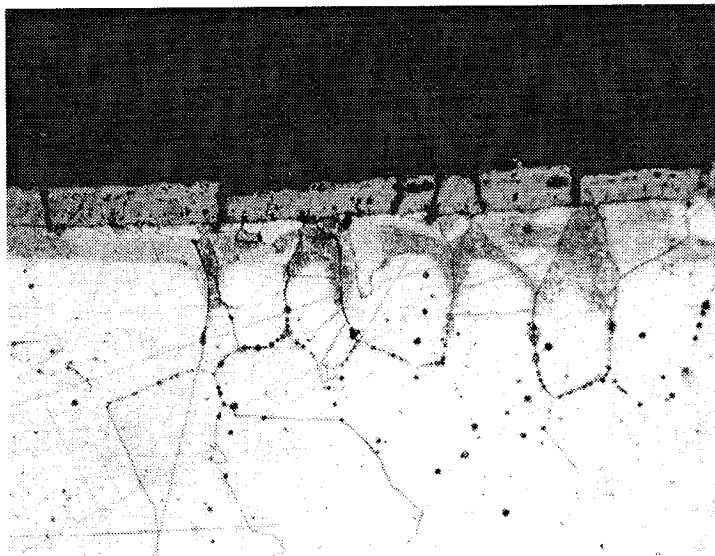
Sample No. 17a, stripe

Coating thickness: 0.00635cm
Stripe not shown.
Cannot determine corrosion.

Tested 2270 hours at 1073K.

Magnification: 200x
Etched

Tungsten Stripe thickness:
0.00475cm to 0.00635cm.
Cannot determine corrosion.

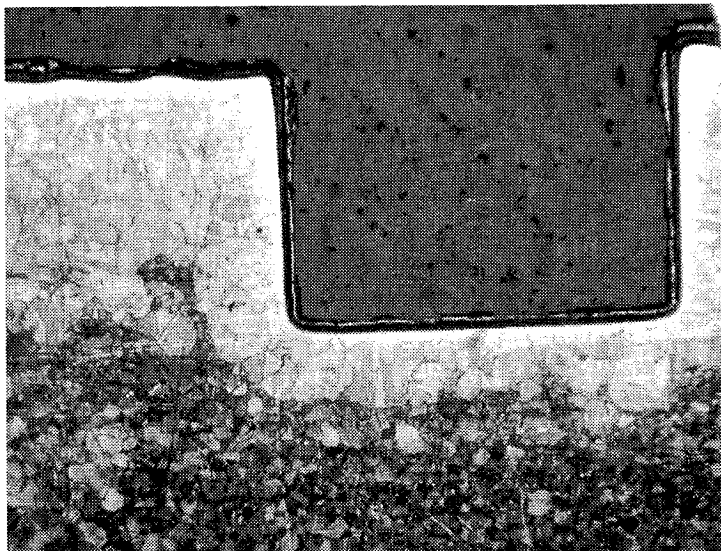
Task 3

Magnification: 50x

Etched

Vacuum fired: 1073K for 8 hr.

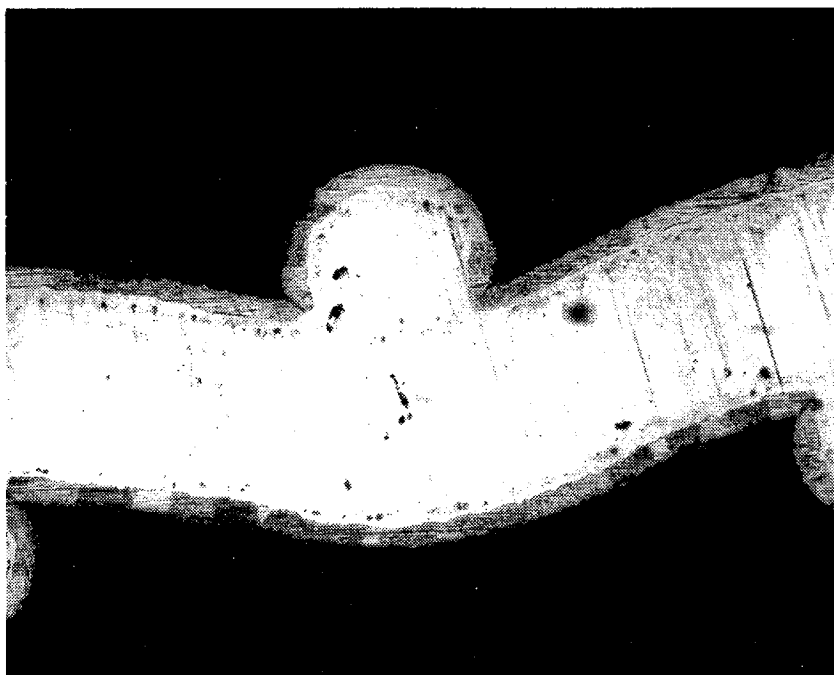
Sample No. 4

Magnification: 250x

Etched

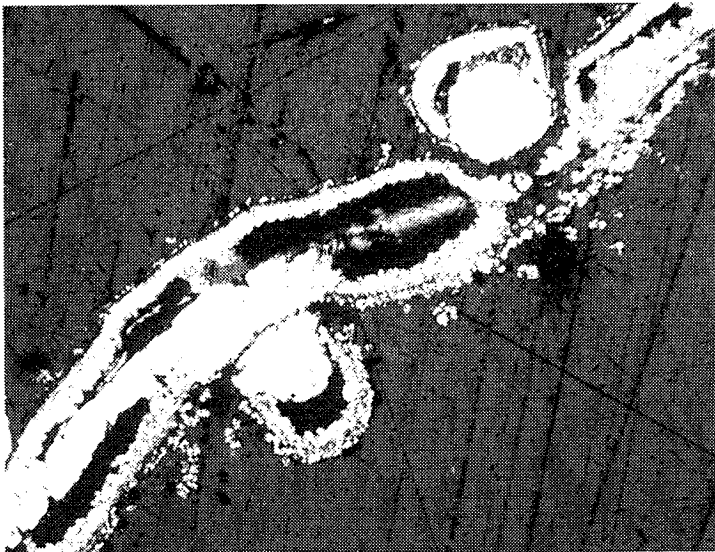
Task 4
Sample No. 4

Magnification: 200x
Etched

Pre-Matrix Pipe No. 1
